**Hamilton
Standard**

LIGHTWEIGHT LONG LIFE HEAT EXCHANGER

FINAL REPORT

PREPARED UNDER CONTRACT NAS 9-13552

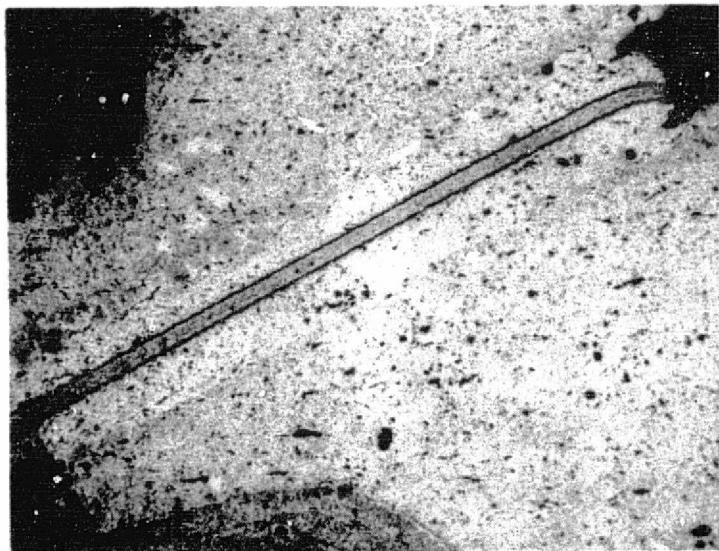
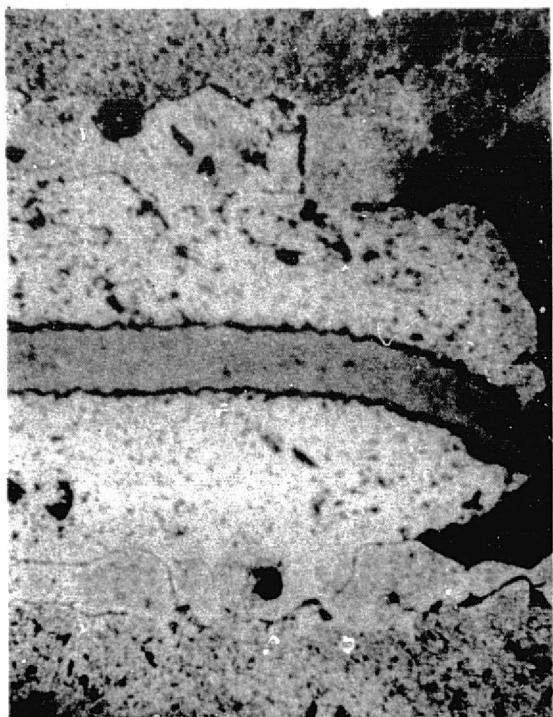
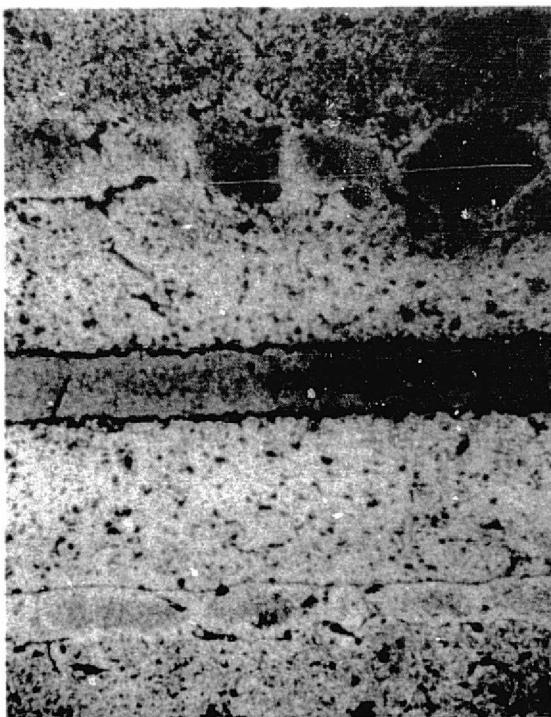
FIGURE 49 MODULE #2 EXAMPLES OF LACK
OF WETTING AFTER BRAZE

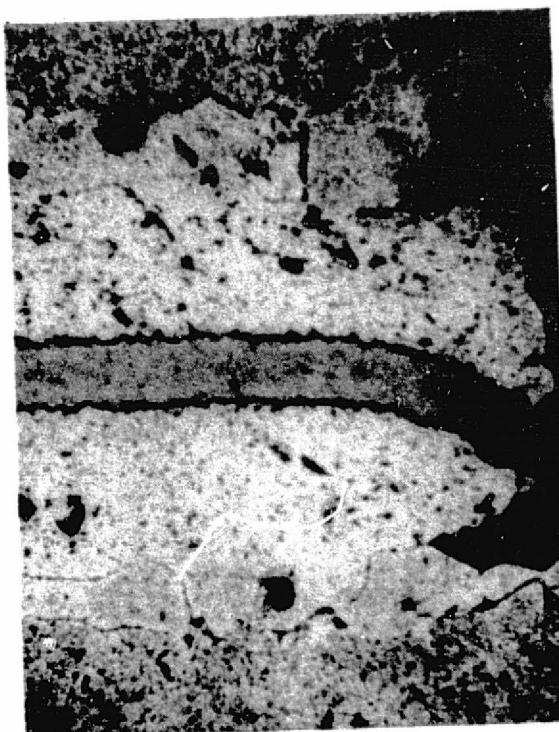
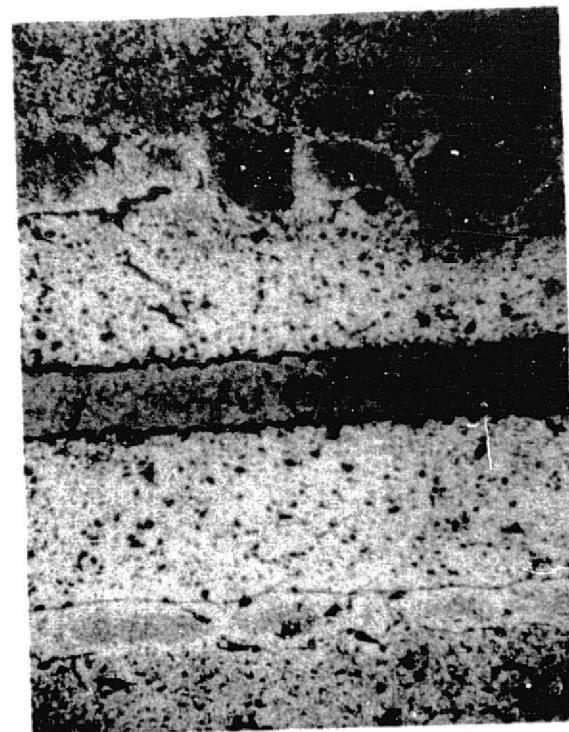
FIGURE 50

The second module then was stacked and brazed. A slightly different set-up and braze process was utilized, in an attempt to reduce the time and manpower required for core brazing. The quality of the resultant braze joints was marginally acceptable. Joints were adequate in that weld was achieved as in a normal production application with the module holding pressure at the proof level. However, the incidence of leakage after braze was high. Figure 48 indicates the leakage areas, and the joints showed unbrazed areas similar to those found on the full size core, S/N 2. Typical joints are shown in figures 49 and 50. As a result of the experience with module 2, the process change was rejected for future use.

MODULE #2, EXAMPLE OF POOR BRAZE ALONG FULL LENGTH
OF A JOINT EXCEPT FOR SMALL AREA NEAR END

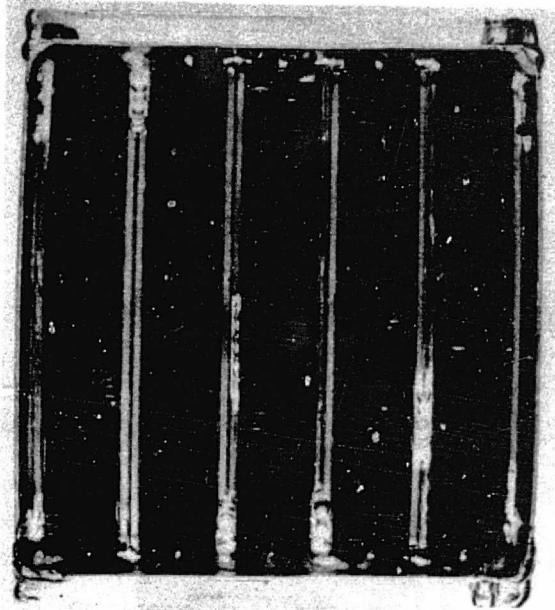
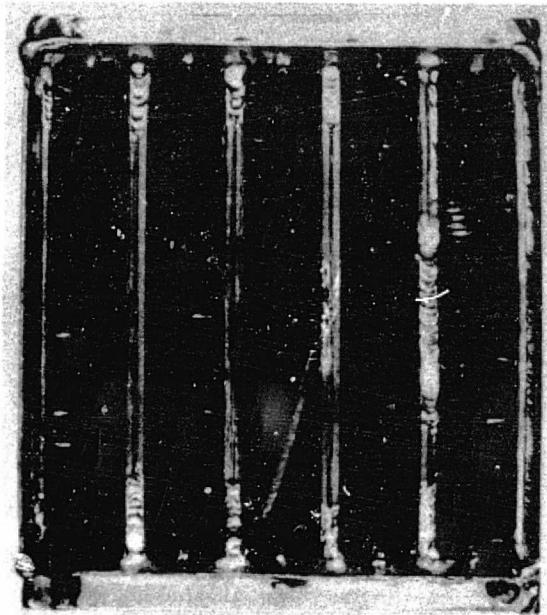
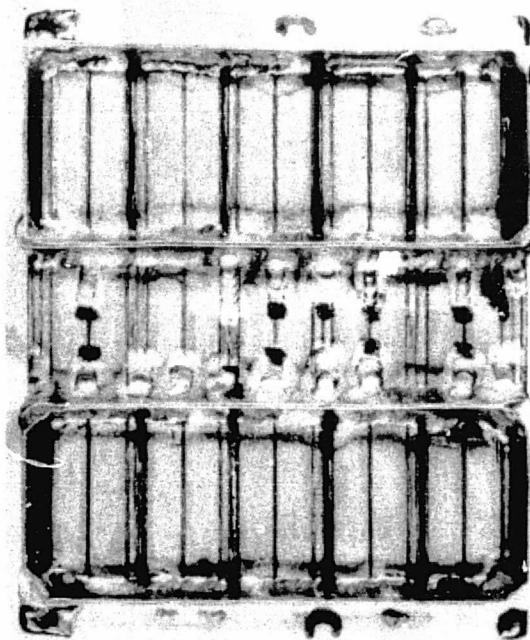
FIGURE 51 MODULE #3 LEAKAGE AREAS (INDICATED BY DARKENED AREAS ON FACES A AND C)

The metallurgical evaluation of the third core module indicated that excellent internal brazing of the core was accomplished. The core had passed the 620.5 kN/m² (90 psig) proof pressure test. Although some leakage had been encountered the investigation revealed that the leakage was all external, originating from under the weld where the core bands were attached. Figure 51 shows four faces of the core. Faces A and C indicate leakage locations by the small black dots. Further investigation revealed poor filleting at the end of the #12 parting sheet (air bar). This lack of filleting occurs with other heat exchangers being produced for various aircraft programs and is generally weld repaired. The core band weld should have penetrated sufficiently to eliminate the leakage; when it did not, it was decided to investigate the core rather than do additional weld repair. Figure 52 shows the end of a typical air bar and the lack of filleting at the end of the bar is easily seen.

- Gas flow circulation in the retort was revised.
- More stringent cleanliness requirements were implemented.
- The closure bars were reversed to provide better retention of the closure bars to prevent "popping".
- A static load was substituted for the bellows load, as a more accurate loading method in the brazing fixture.
- The stack-up and braze were monitored 100 percent to insure cleanliness of parts and integrity of the stack-up.

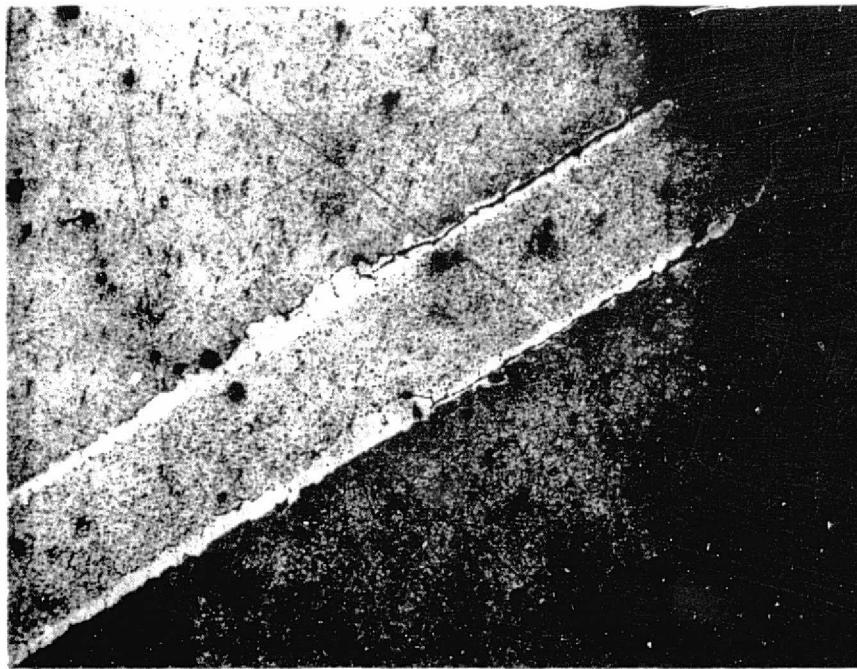
FIGURE 52 MODULE #3, TYPICAL AIR BAR, ILLUSTRATING
LACK OF FILLETING AT END

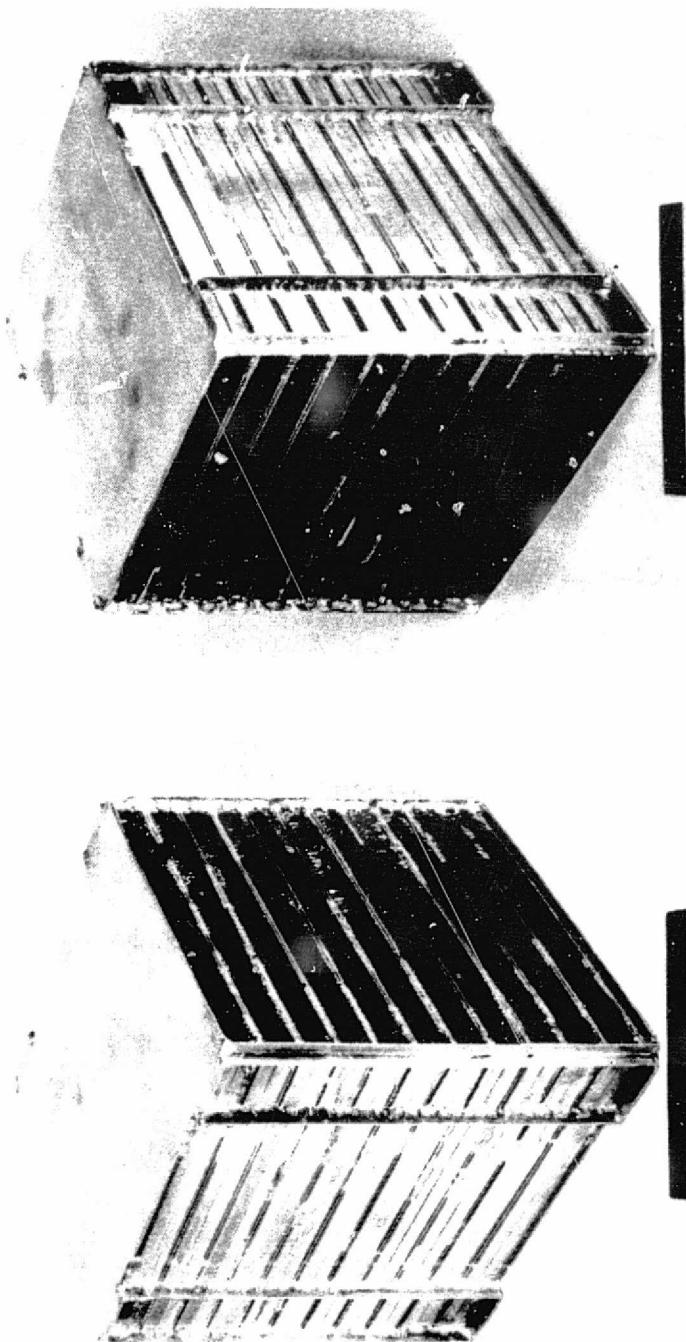
FIGURE 53 FINAL HEAT EXCHANGER CORE

Therefore, the core of the final heat exchanger was brazed, core bands welded in place and a number of leaks were repaired. Photo, figure 53, shows the leak tight core prior to installation of brackets, flanges and headers. Final leak testing utilized air at 620.5 kN/m² (75 psig) with the unit immersed in water. Leaks resulting in bubbles as small as approximately 0.127 mm (0.005 inch) were detected and corrected.
